TOWN OF OCEAN ISLE BEACH 2025 BEACH MANAGEMENT PLAN

**PREPARED FOR
TOWN OF OCEAN ISLE BEACH, NC**

**PREPARED BY
COASTAL PROTECTION ENGINEERING OF NORTH CAROLINA, INC.**

April 2025

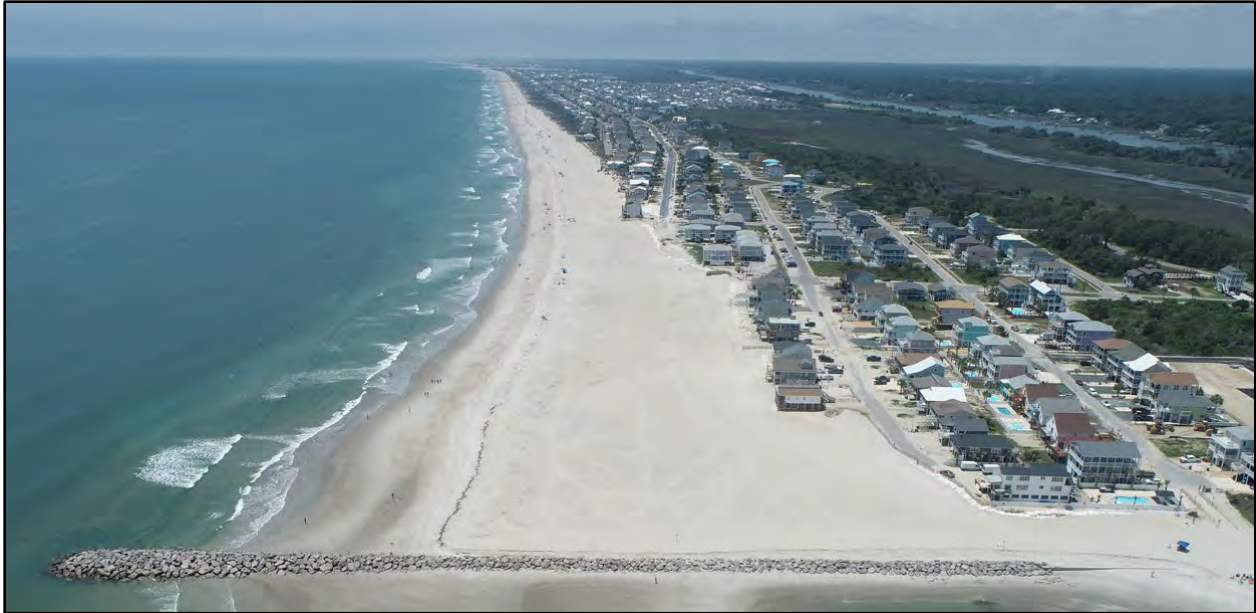
(CPE Photograph taken on May 26, 2022 soon after the construction of the 2022 CSR Maintenance Event and 2022 East End Shoreline Protection Project)

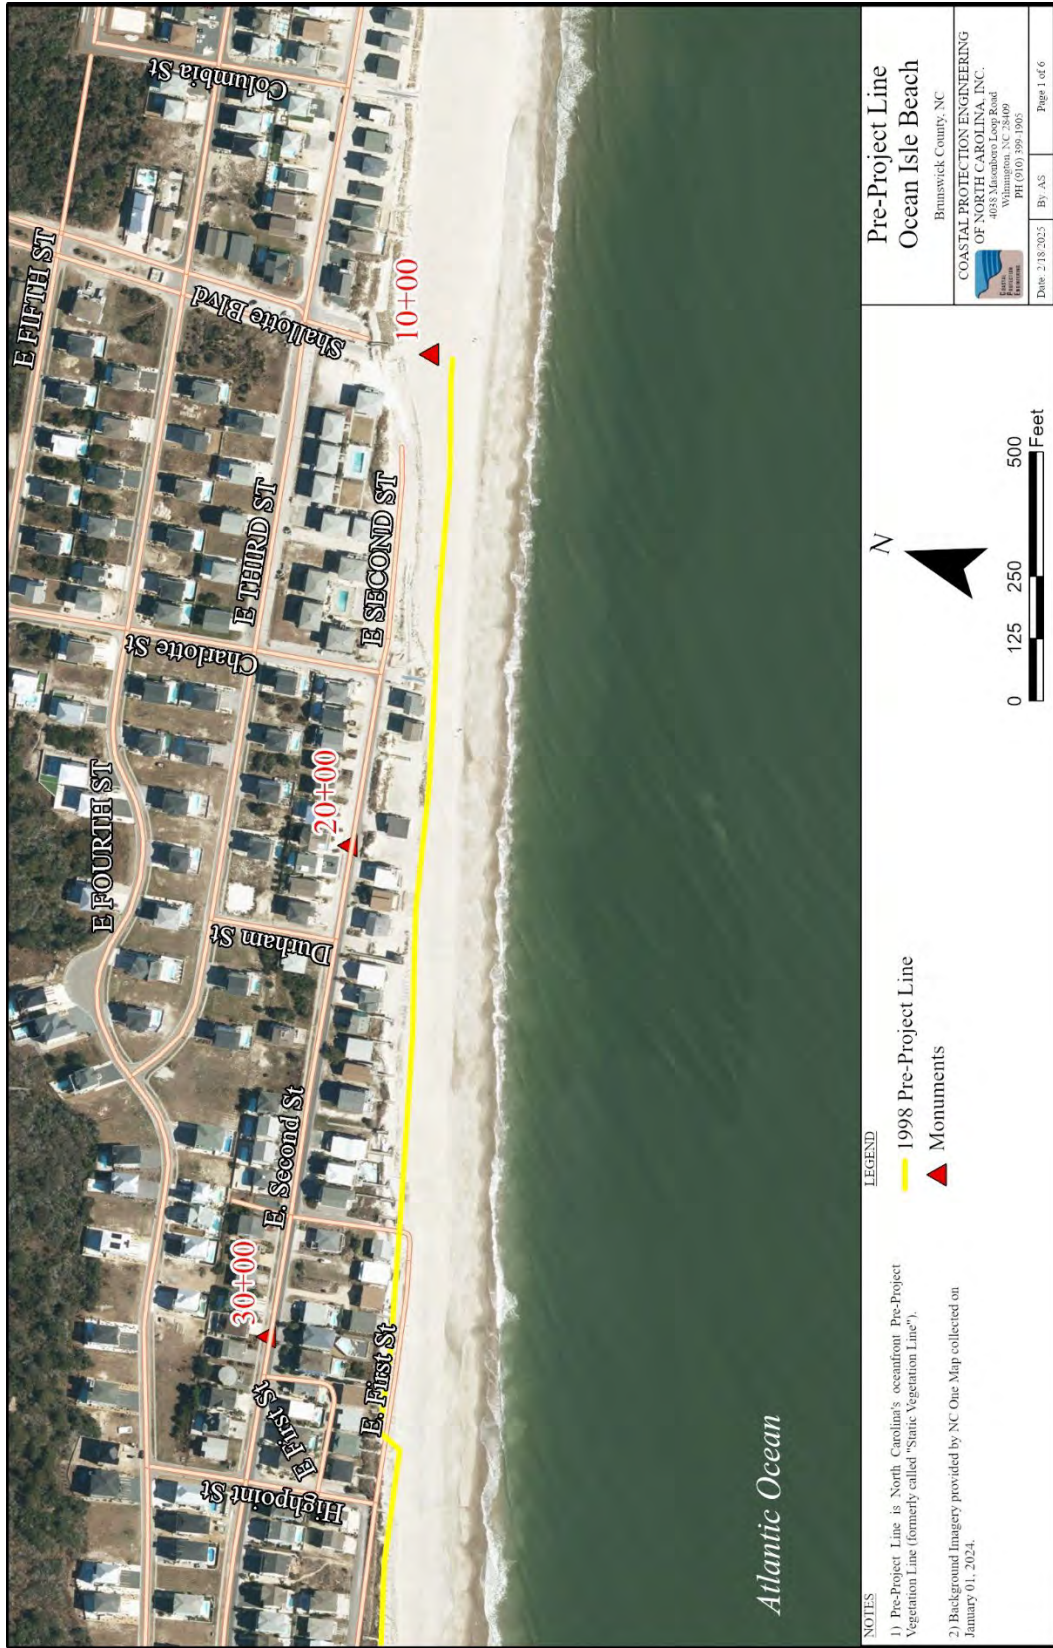
Figure 2a. Pre-Project Vegetation Line on Ocean Isle Beach

Pre-Project Line
Ocean Isle Beach
 Brunswick County, NC

NOTES
 1) Pre-Project Line is North Carolina's oceanfront Pre-Project Vegetation Line (formerly called "Static Vegetation Line").
 2) Background Imagery provided by NC One Map collected on January 01, 2024.

In 2022, the North Carolina Coastal Resources Commission (CRC) implemented rule changes that redefined the "static vegetation line" as the "pre-project vegetation line". Further, the changes replaced the Static Line Exception policy with a more flexible, long-term management approach that encourages proactive, comprehensive beach management instead of focusing only on development restrictions. This new approach, as defined within 15A NCAC 07J .1201, allows a town to develop a Beach Management Plan (BMP) to request an exception from the pre-project vegetation line. Figures 2a-2f depict the location of the 1998 Pre-Project Vegetation Line spanning the length of the 3.25-mile CSRSM project on Ocean Isle Beach.

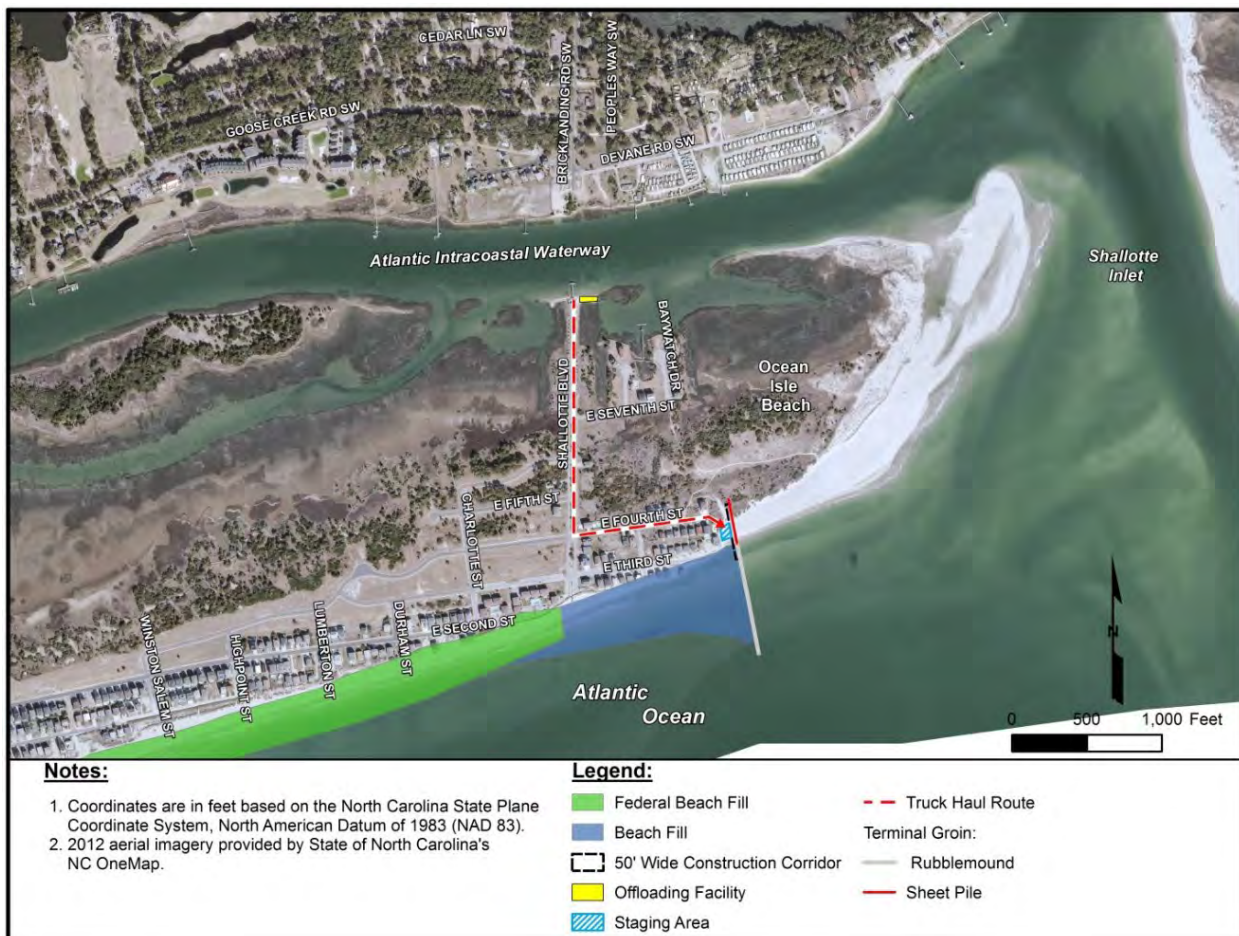
Figure 6. Location of the terminal groin and associated beach fill located on the eastern portion of Ocean Isle Beach

Between November 2021 and April 2022, the Town constructed their “Ocean Isle Beach East End Shoreline Protection Project” which entailed two components: 1) the construction of a rubble mound terminal groin and 2) the pre-filling of an accretion fillet using beach fill (Figure 6). The primary purpose of the project was to provide a stable beach configuration (increased beach width) east of the Federal CSRSM project. Specifically, the project along with the maintenance of the CSRSM project served to help stabilize 3,214 linear feet of oceanfront shoreline between the terminal groin at Station -2+00 to an area just east of Highpoint Street at Station 30+00.

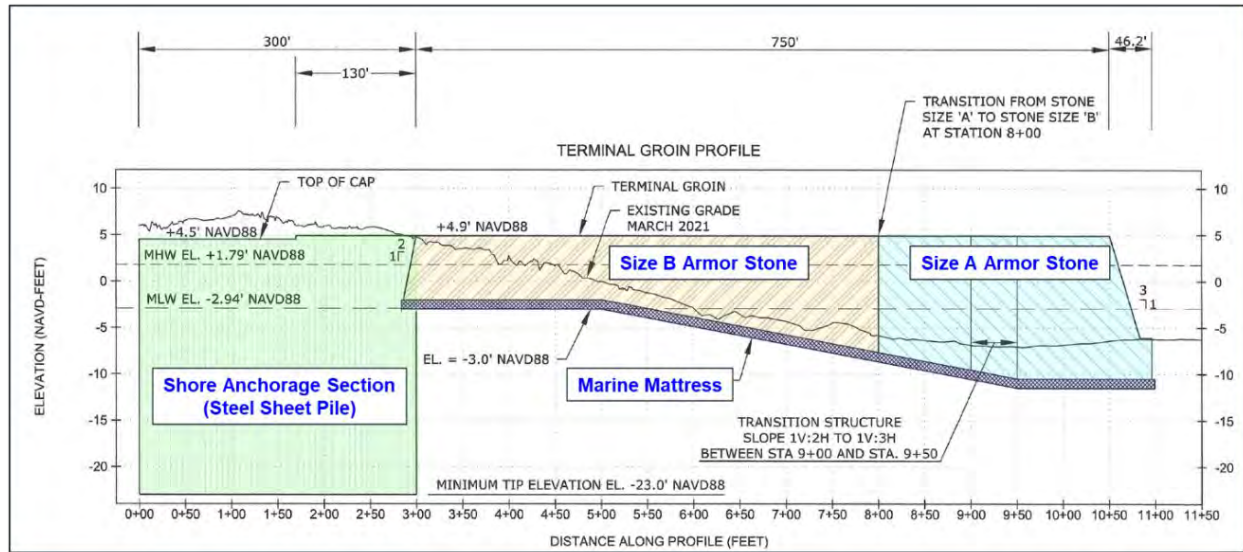
Figure 7. Cross-section of the terminal groin structure design template.

The terminal groin structure was designed to retain sediment along the east end of the Town's developed oceanfront shoreline while reorienting the shore alignment comparable to that of the Federal CSRSM Project. The construction of the 1,050 ft-long terminal groin component of the Town's Shoreline Protection Project began in November 2021 and was completed in April 2022. The 750-foot rubblemound portion of the terminal groin was constructed to a crest elevation of +4.9 ft. NAVD with loosely placed armor stone on top of a 1-foot-thick marine mattress foundation. Approximately 20,664 tons of armor stone were used to construct the rubblemound terminal groin structure. The rubblemound structure was constructed with two sizes of stone: Size B (3.1 to 5.1 tons) and Size A (5.5 tons to 8.9 tons). The landward 500 feet of the groin was constructed with Size B stone and the seaward 250 feet was constructed with Size A stone. The 300-foot shore anchorage section was constructed with steel sheet piles topped with a 2 ft. wide concrete cap. This shore anchorage section maintained an elevation of +4.9 feet NAVD88 for a distance of 130 feet extending from the landward end of the rubblemound section and was reduced to +4.5 feet NAVD88 for the remaining 170 feet. Figure 7 shows the cross-section of the terminal groin structure design template. With the construction of the terminal groin and the re-oriented shore alignment, the Ocean Isle Beach East End Shoreline Protection Project, the erosion rate on the east end of Ocean Isle Beach is expected to slow, given a reduction in the influence of Shallotte Inlet on sediment transport within the project area. In order to minimize potential impacts to the shoreline east of the structure, the design required that the rubblemound portion of the structure be constructed with loosely placed armor stones (no core) to create voids between the stones which would allow some sediment to pass through the structure. Also, in order to allow sediment to pass over the structure the crest elevation of the structure was designed to be approximately 1-foot below the natural beach elevation within the area. Furthermore, with the terminal groin in place, it is anticipated that the rates of erosion along the oceanfront shoreline west of the terminal groin will be reduced to a point in which the nourishment interval for the CSRSM project (time between maintenance events) will be extended, thus resulting in a reduction of potential environmental impacts and resulting in cost savings for the Town and other cost share partners.

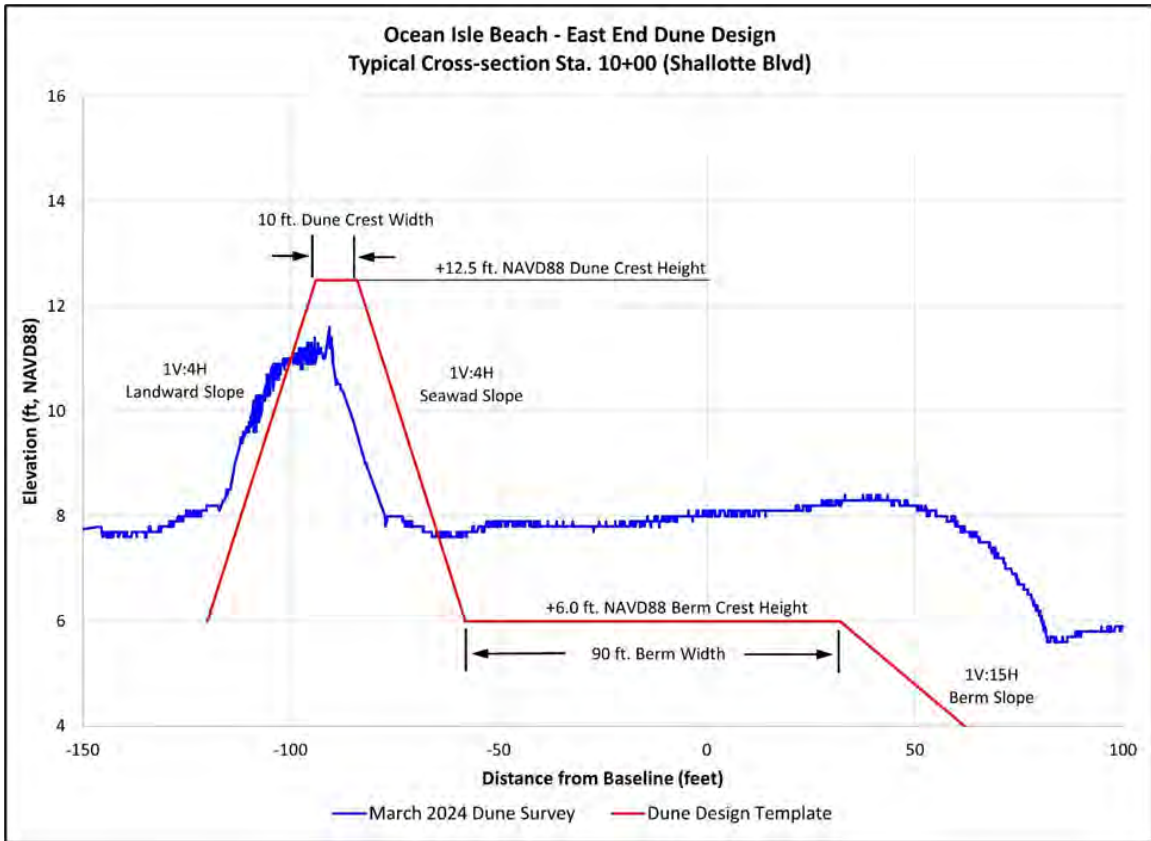
Figure 8. Cross section view of the proposed dune and typical berm template.

The dune design includes a 10-foot-wide crest with a varying elevation of +11.5 ft. NAVD88 and +12.5 ft NAVD88 and 1V:4H front and back side slopes (Figure 8). The new dunes will be planted with native vegetation and sand fencing will be installed. The project also involves placement and grading of material to raise the elevation of the existing vehicle cross-over at the 4th St. beach access. The material used to construct the new dunes were obtained from a permitted upland sand mine and transported via dump trucks from the mine to the project site. See Appendix D for the project’s construction drawings.

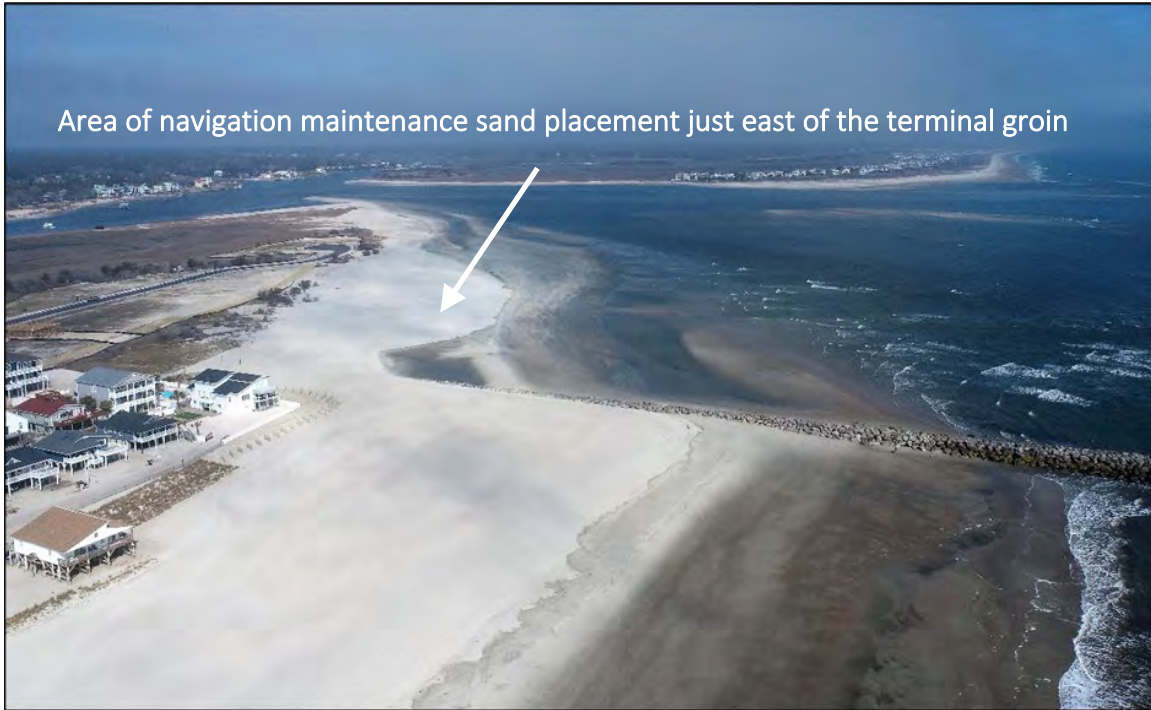
Figure 9. USACE Navigation maintenance material placed east of the terminal groin along the inlet shoreline (Photo taken 2/22/23)

In addition to the beach fill placed by the USACE within the confines of the Town’s CSRM project, the USACE has periodically deposited material dredged during the maintenance of the Atlantic Intracoastal Waterway (AIWW) at the intersection with Shallotte Inlet (Shallotte Inlet Crossing) and at the intersection of the Shallotte River (Shallotte River Crossing). The majority of this material has been deposited within the area fronting the development east of Shallotte Boulevard (i.e., outside the limits of the federal project) (Figure 9). Table 1 below details the available information from beneficial use placement events since 2016.

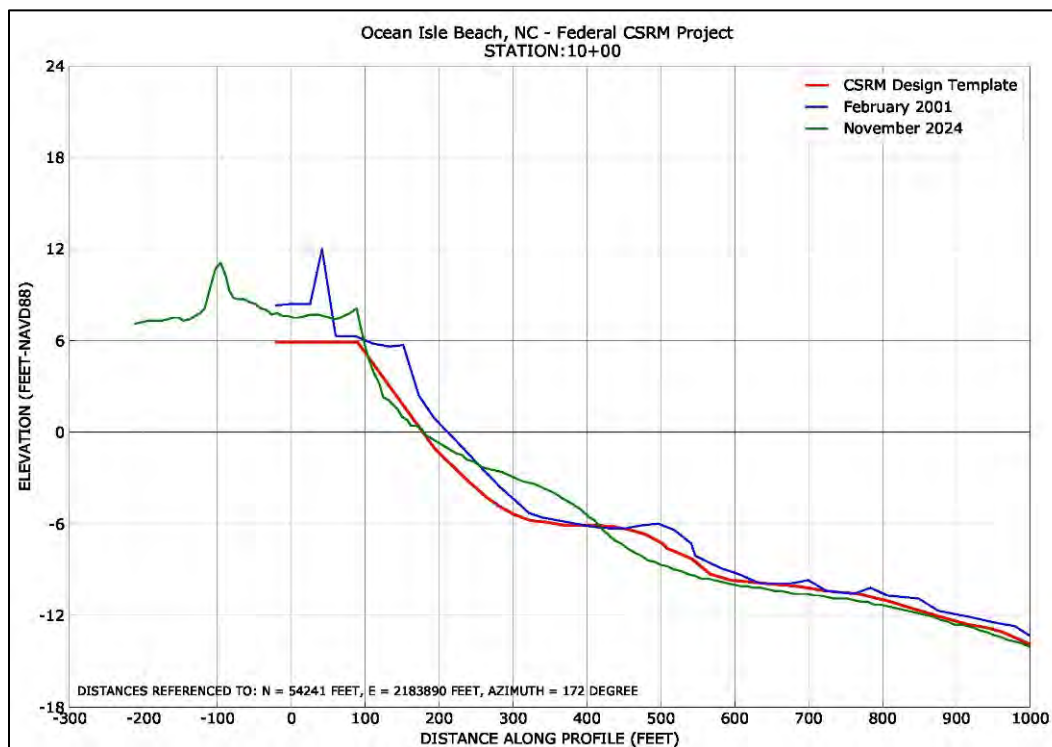
Figure 17. Station 10+00 - CSRSM Design Template, February 2001 and November 2024 surveys.

As of November 2024, the analysis calculated an average fill volume remaining of 260,500 cy above -8 ft. NAVD88, seaward of the design template, between stations 10+00 and 80+00. Between June 2022 and November 2024, the long-term volume change rate was calculated to be -132,400 cy/yr. over the 2.4-year monitoring period, following the construction of the 2022 CSRSM project. The analysis of the volumetric changes for the CSRSM project area between stations 10+00 and 80+00 estimated that this portion of the project has an estimated 2.0 years remaining considering the changes above -8 ft. NAVD88. Figures 17 through 20 provide a depiction of the volume remaining seaward of the CSRSM project design template, where fill was placed in 2022, compared to the conditions surveyed in November 2024 at stations 10+00, 30+00, 50+00, and 70+00. The February 2001 survey is also included to show the conditions surveyed prior to the initiation of the CSRSM project.

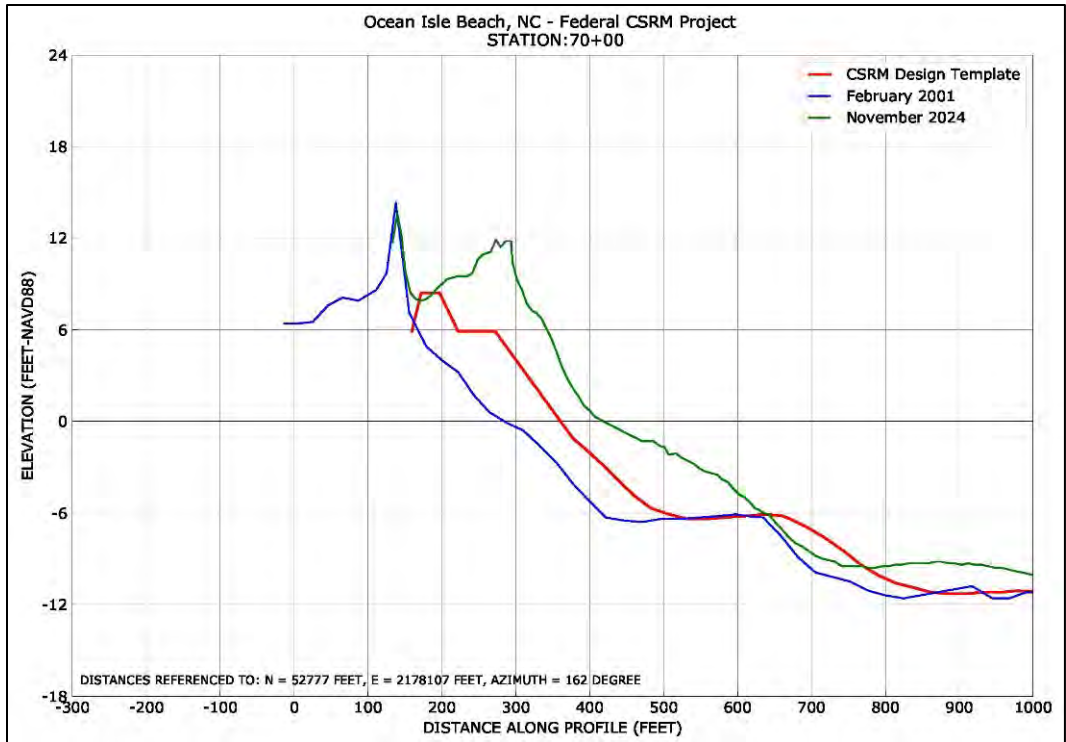
Figure 20. Station 70+00 - CSRM Design Template, February 2001 and November 2024 surveys.

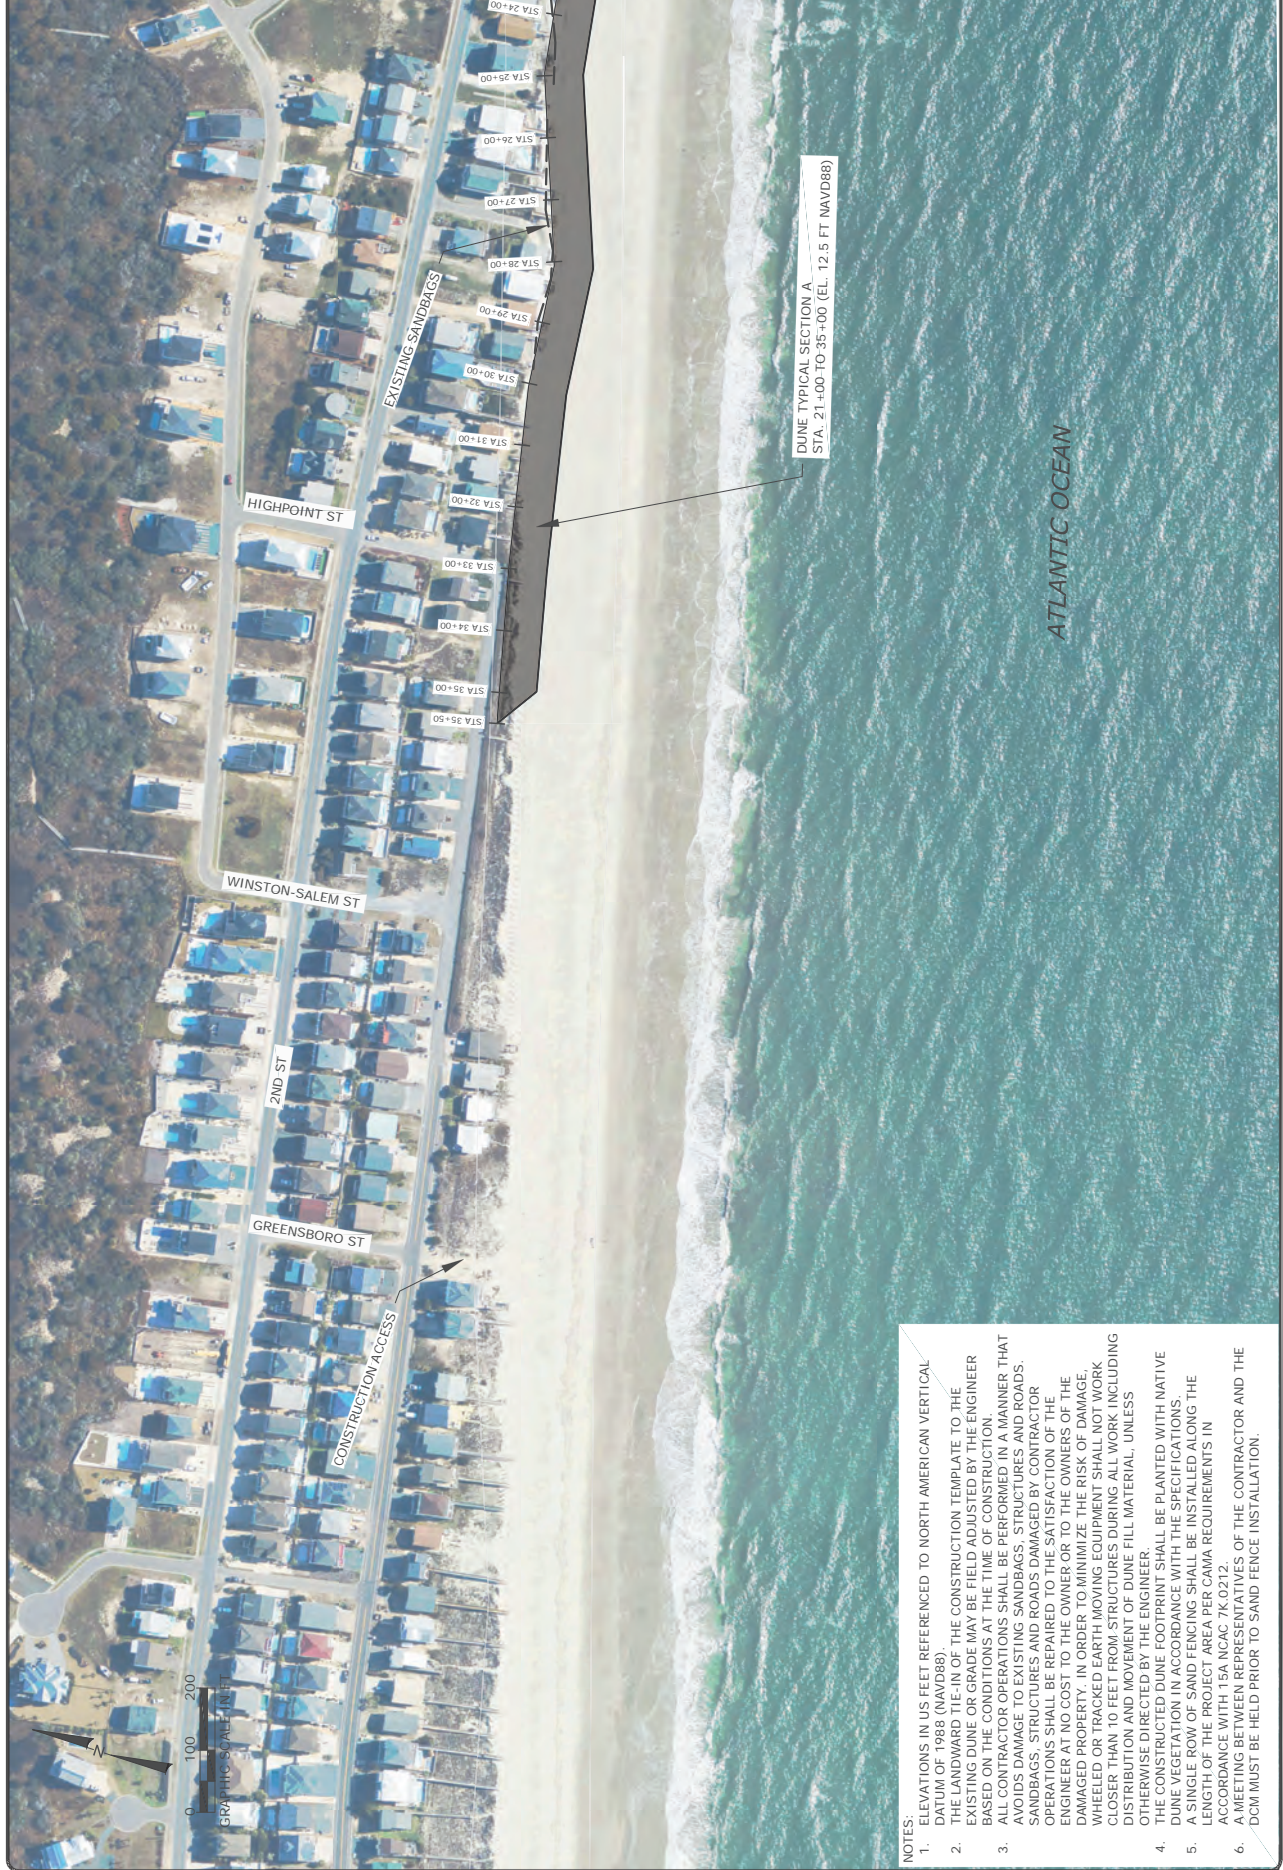
AS NOTED	
DATE:	2/17/2025
DESIGNED BY:	JG, SL
CHECKED BY:	
DATE:	
PROJECT:	DUNE PROJECT
LOCATION:	BRUNSWICK COUNTY, NORTH CAROLINA
VIEW:	PLAN VIEW

- NOTES:
- ELEVATIONS IN US FEET REFERENCED TO NORTH AMERICAN VERTICAL DATUM OF 1988 (NAVD88).
 - THE LANDWARD TIE-IN OF THE CONSTRUCTION TEMPLATE TO THE EXISTING DUNE OR GRADE MAY BE FIELD ADJUSTED BY THE ENGINEER BASED ON THE CONDITIONS AT THE TIME OF CONSTRUCTION.
