# **TOWN OF OCEAN ISLE BEACH 2025 BEACH MANAGEMENT PLAN**

**PREPARED FOR  
TOWN OF OCEAN ISLE BEACH, NC**

**PREPARED BY  
COASTAL PROTECTION ENGINEERING OF NORTH CAROLINA, INC.**

**March 2025**

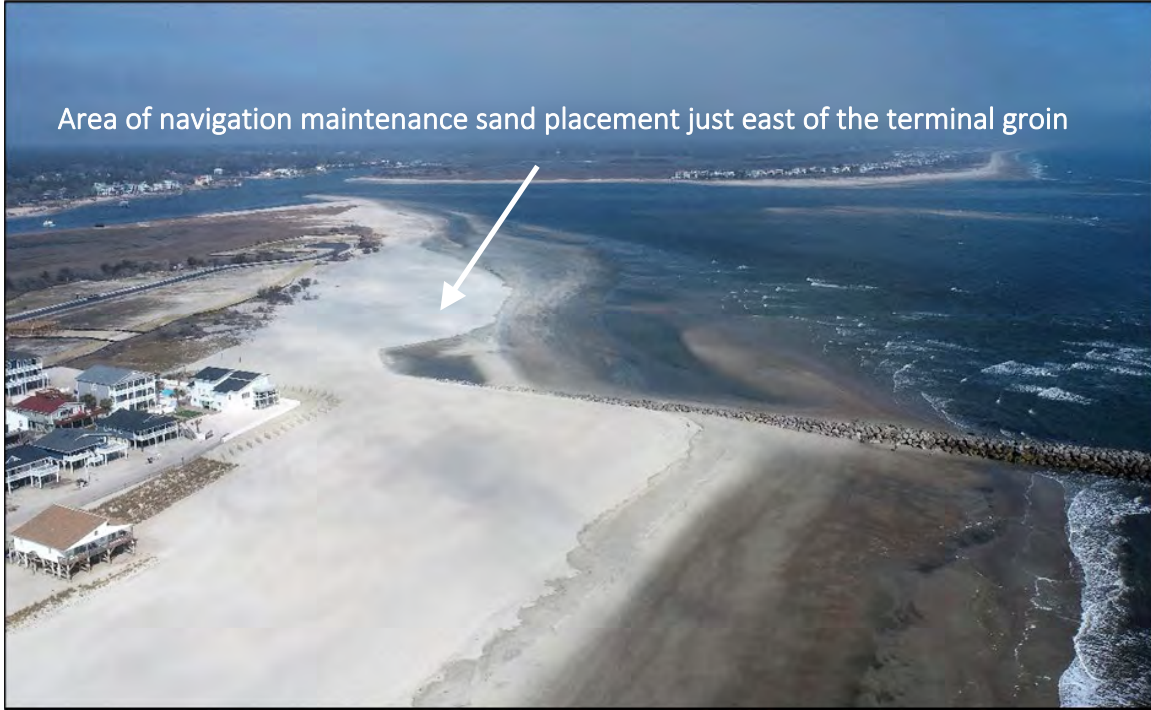
Figure 9. USACE Navigation maintenance material placed east of the terminal groin along the inlet shoreline (Photo taken 2/22/23)

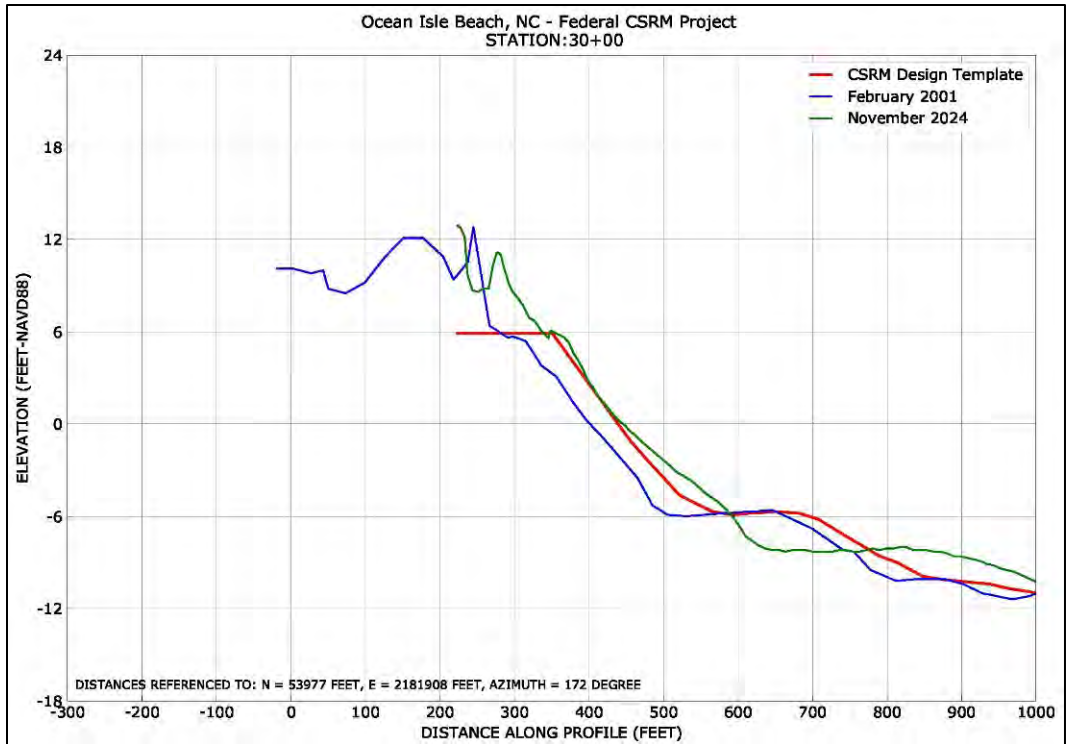
Figure 18. Station 30+00 - CSR Design Template, February 2001 and November 2024 surveys.
